SURVEY REPORT NO: ADM/JAM/INS\_01281

## LOSS PREVENTION SURVEY.

This is to certify that at the request of BHEL JHANSI vide their award of contract ref No. CDC/T/12-13 /09 /A. Dt 12/10/2012 to our JV partner Schenker India Pvt Ltd, we undersigned surveyor had carried out loss prevention / warranty survey for Transportation of 41 MVA Generator transformer for M/s. HPSEB –UHL –Stage 111 (Size – 5200mm (L)X 2450 mm (W) X 3600 mm (H) – 42 MT) from TASHIJONG (Taragat) alongside National Highway No. 20, about 28 KM from Baijnath in Himachal Pradesh to UHL Stage 111 Site (34 KM) on 11<sup>th</sup> October 2012.

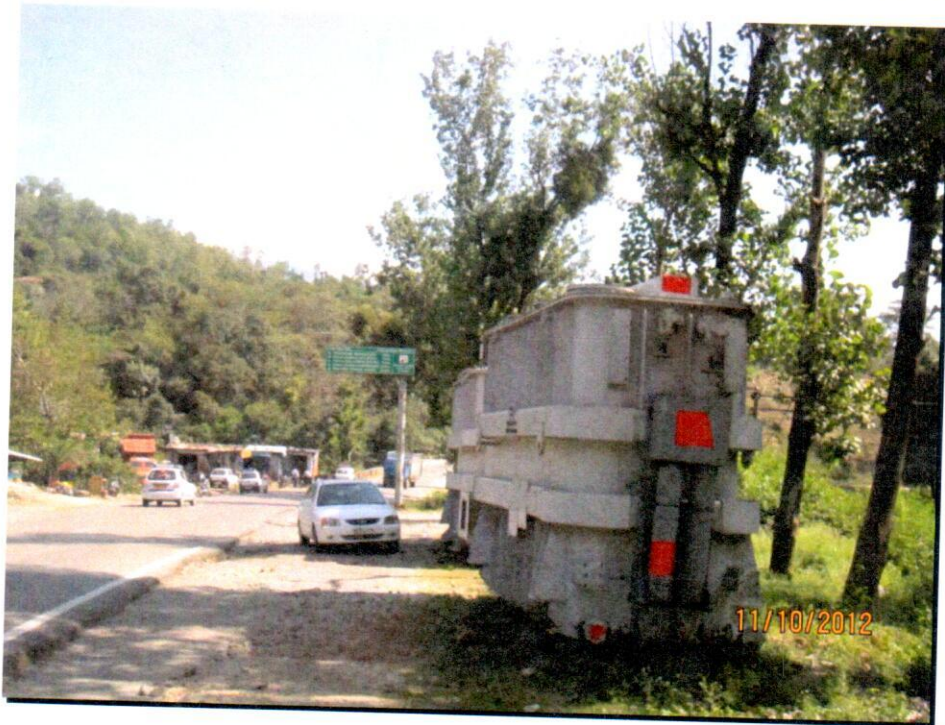
**Taragat to Banandar road 4 KM:** -- NH No. 20 ( Pathankot- Mandi )

This section is two line road and all bridges are classified 70R.

Modification recommended

1. Side filling on the right side of Bridge No . 127/1
2. Leveling the curve by sand bag in first curve the accident happened (03KM)

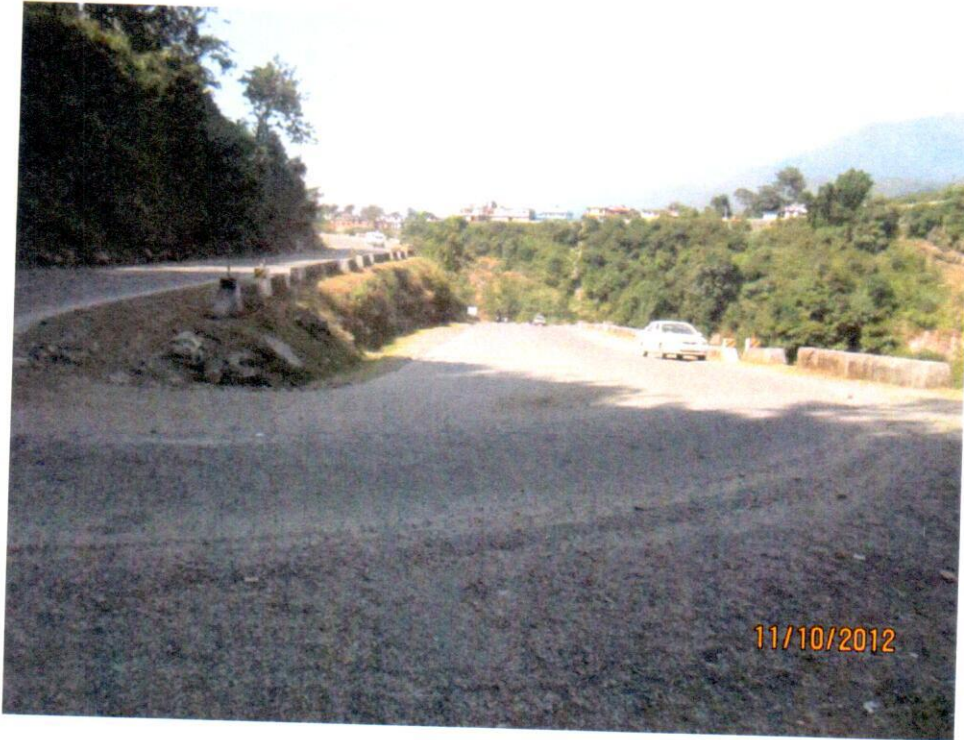
## BANANDER ROAD – NH No. 20 TO CHOWBEEN – 10 KM.

This distance 10 KM is single line road . Road condition is good. All bridges are classified 40 R. This 40R is also referred to Class A - means a payload of 40 Tons can be moved safely on 40 R Bridges. Railway crossing at 5 KM. (Narrow Gauge 762mm). Required width in the rail crossing is available. At 11 KM turning near Kathal required side filling and compacting. All town in the route shall be crossed only between 6 AM to 8 AM or 2 PM to 5 PM.

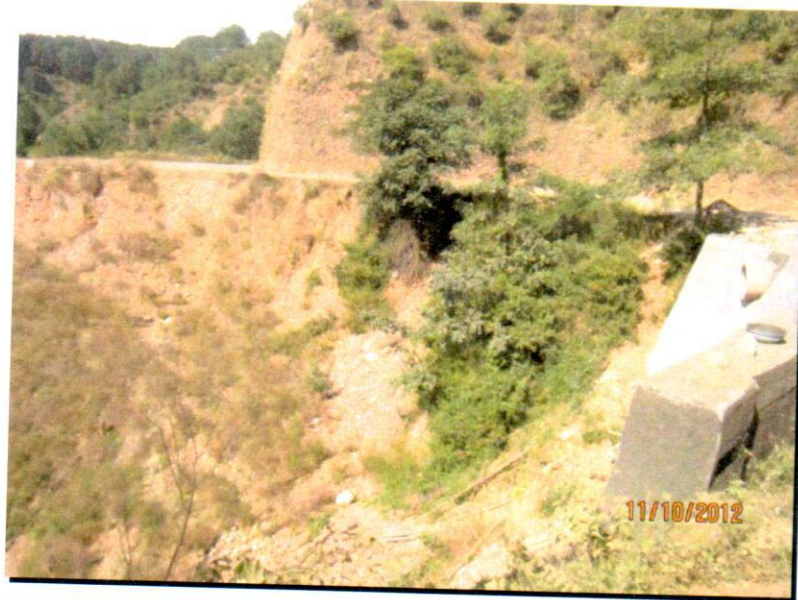
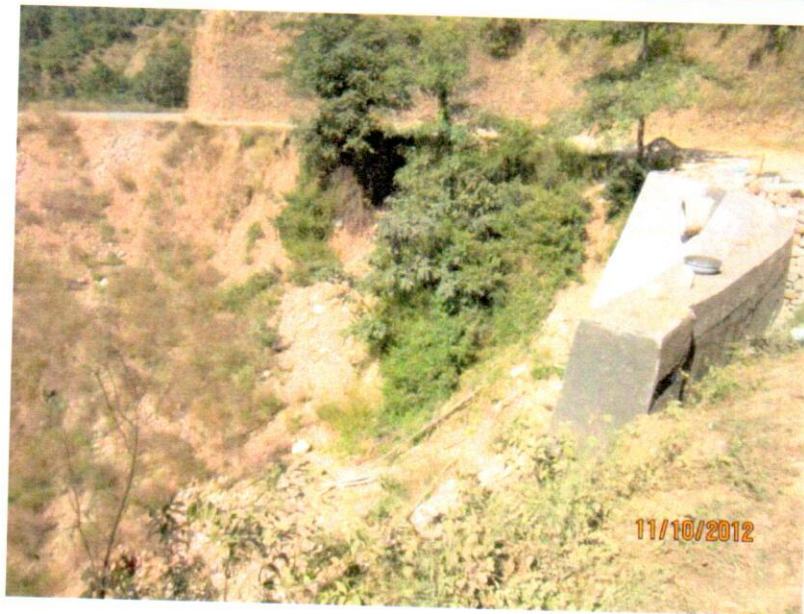
## CHOWBEEN to SINU - 8 KM

This is location 1<sup>st</sup> transformer accident. Side wall construction in progress and turning radius available.

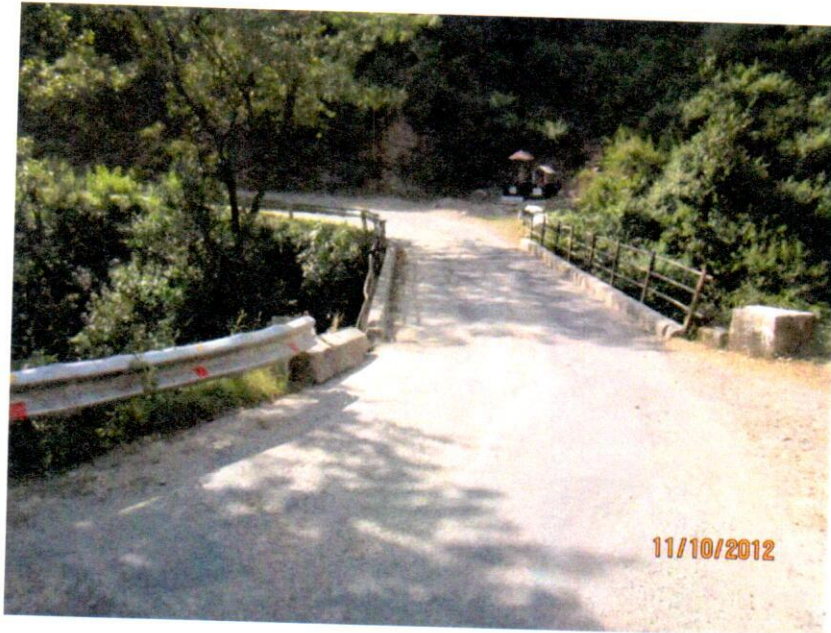
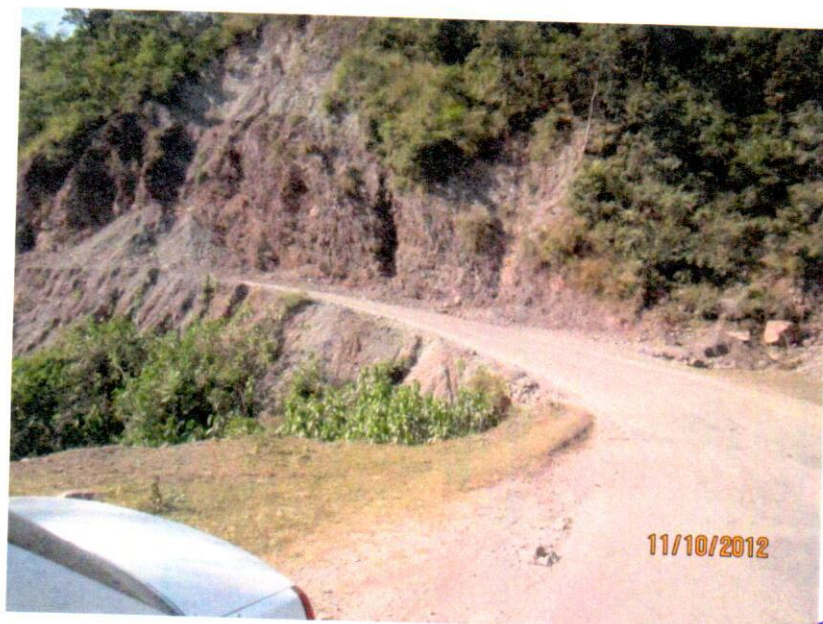
## SINU to UHL SITE. 16 KM.

Bridges are Steel girder with classification 40 R, Culverts are single RCC Slab, Main location removal of earth required for width to pass the trailer. Needs 3 bend widening and increasing its outer radius.

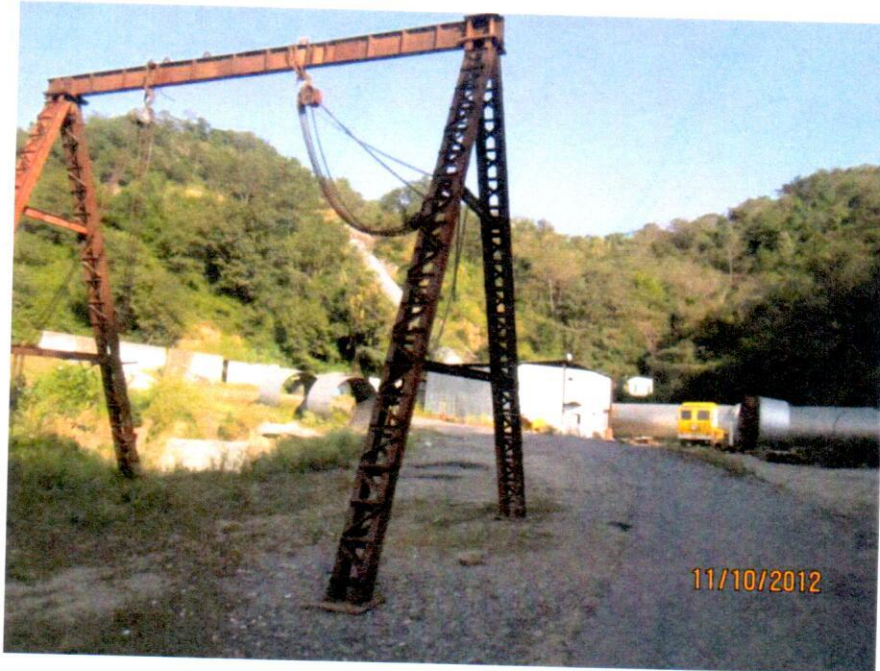
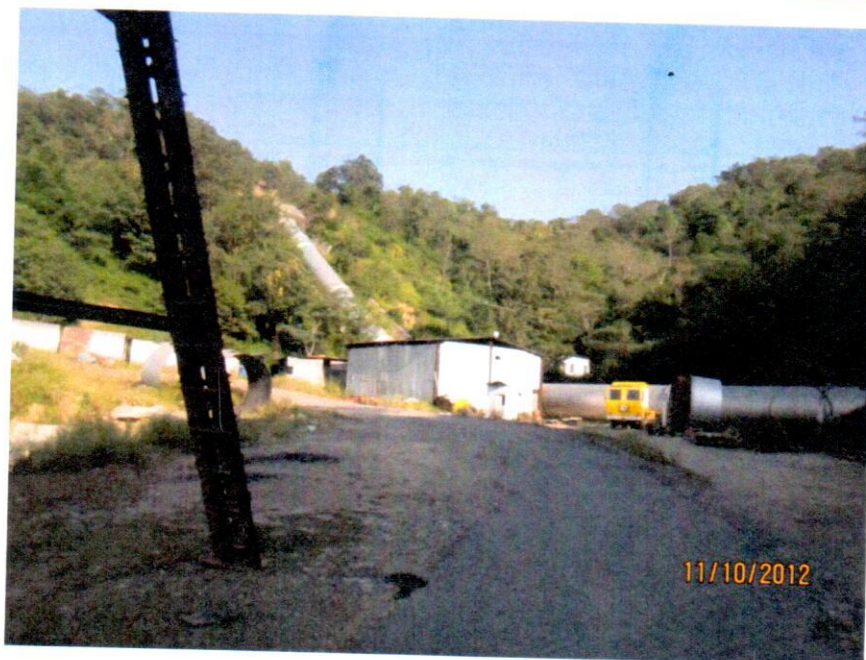
## UHL SITE -

UHL site is along side of the road. Observed required road width for parking of trailer for unloading.
